Welcome Message

KEC Bearings Pvt Ltd

• Wind Turbine Gear Box Bearing Failure

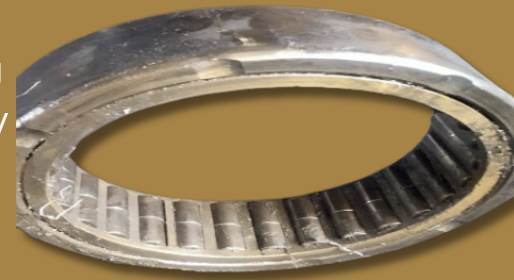
The image shows a full complement bearing, a type of bearing designed to maximize load-carrying capacity by incorporating the maximum number of rolling elements (rollers) within its structure. Unlike standard bearings with cages, full complement bearings eliminate the cage, allowing more rollers to fit into the assembly. This design is particularly suited for applications where heavy radial loads are predominant, as the increased number of rollers distributes the load more evenly. However, this design may trade off higher speed capacity and lubrication efficiency due to increased friction. Full complement bearings are commonly used in industrial machinery, construction equipment, and heavy-duty applications requiring high durability and reliability.

- Use of full complement cylindrical roller bearings with higher load capacity.
- Adoption of advanced steel materials resistant to wear and cracking.

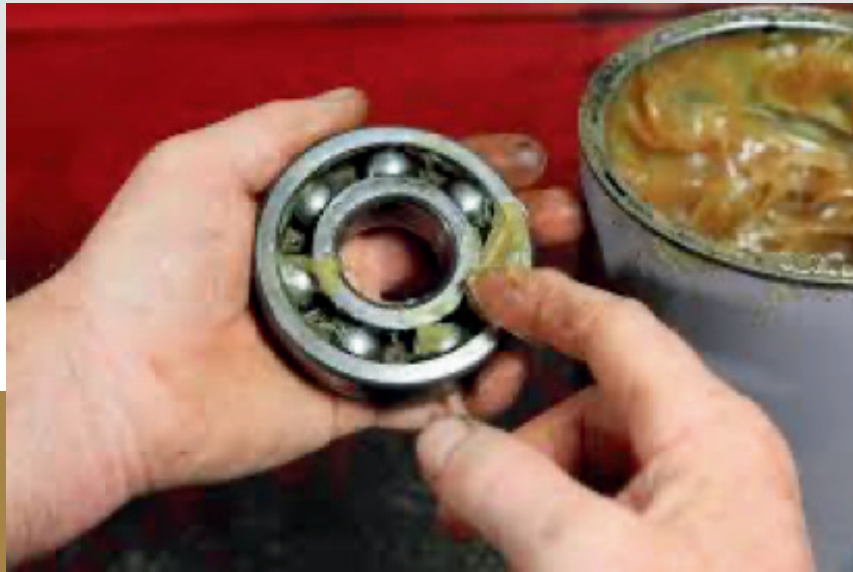
In a 2.5 MW wind turbine, the gearbox began showing abnormal vibrations after 6 years of operation. Inspections revealed failure in the high-speed shaft bearing and planet bearings in the planetary gear stage. The turbine experienced a 30% efficiency drop before it was taken offline for repairs.

- Repeated high loads caused surface cracks in the raceways and rollers, leading to spalling (material flaking).
- This was exacerbated by uneven load distribution due to misalignment.

- Poor lubrication due to inadequate oil viscosity and contamination resulted in metal-to-metal contact.
- Oil analysis revealed high levels of particulate matter and water contamination.

- Microscopic cracks, often associated with hydrogen embrittlement, were found in failed bearing material.
- WEC is linked to electrical discharges or tribo chemical reactions within the lubricant.
